Electrical Resistivity Tomography at Construction Sites in Northeast Thailand with Implications for Building Foundation Design

Rungroj Arjwech and Mark E. Everett

Danastri Lintang Pitaloka Tampubolon (111684602)

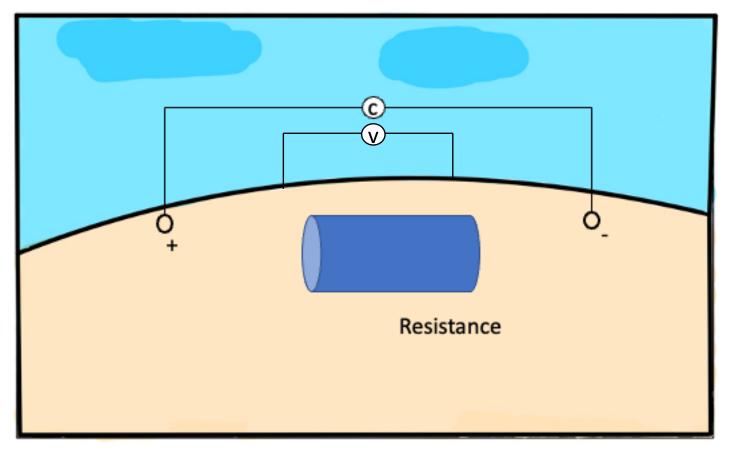
Resistance occurs in the ground, electrical potential differences can be measured

- c current electrodes
- v potensial electrodes

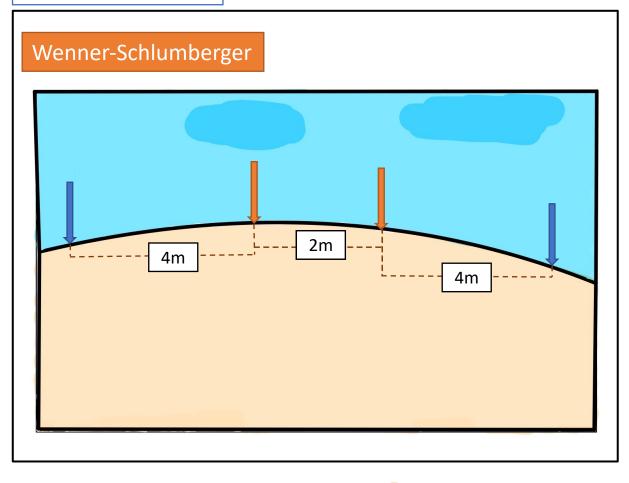
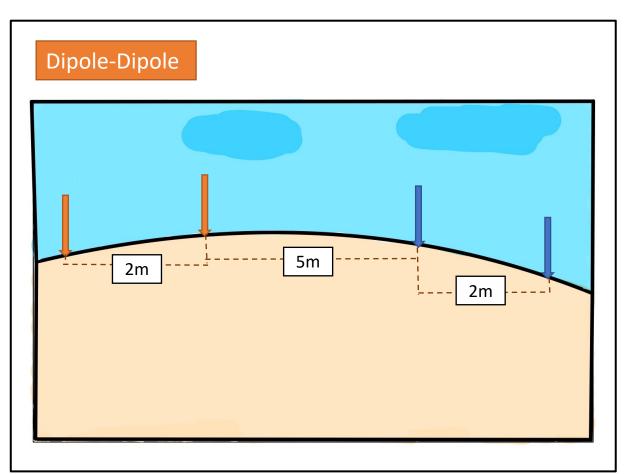
Configurations

Current Electrodes

Potential electrodes

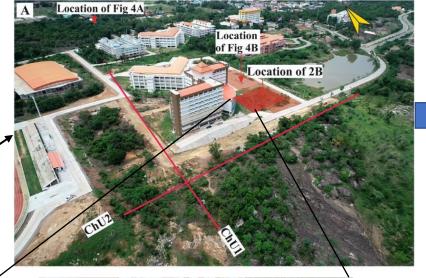
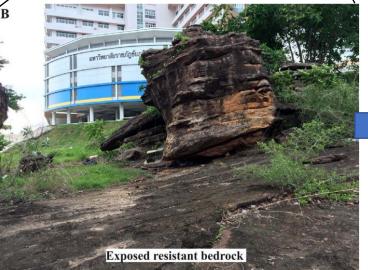
Chaiyaphum Rajabhat University

Two ERT Profiles (ChU1 & ChU2) oriented in N-S and W-E alignment

The conglomeratic sandstone bedrock slopes gently toward the south

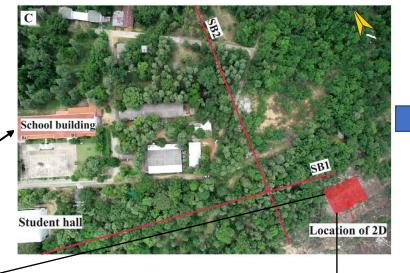
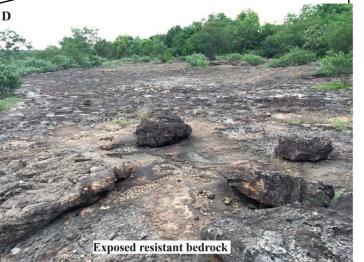
The Subsomboon High School

Two ERT Profiles (SB1 & SB2) oriented in E-W and N-S alignment

A thin sandy soil cover is present across most of the campus, SE-dipping Phu Phan bedrock is exposed to the southeast

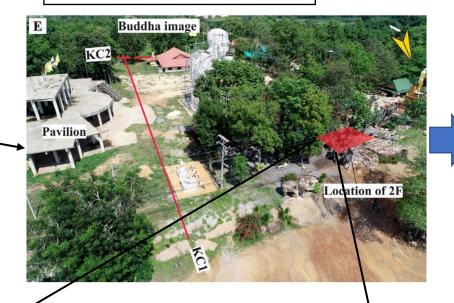
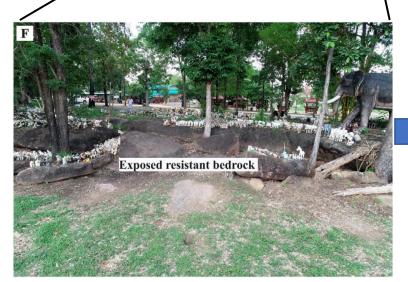
Kham Hau Chang Temple

Two ERT Profiles (KC1 & KC2) oriented in W-E and N-S alignment

The conglomeratic sandstone bedrock that overlies much of the site is well-exposed and slopes gently toward the south.

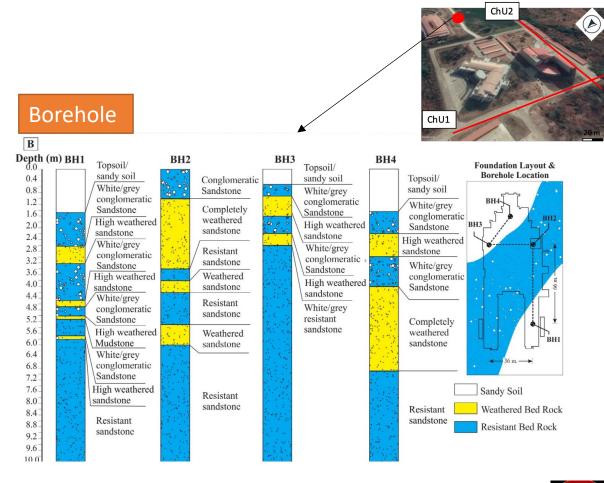
Resistance bedrock Non-Resistance bedrock

resistant and heavily-weathered bedrock units

The ERT does not image each of the thin layers individually

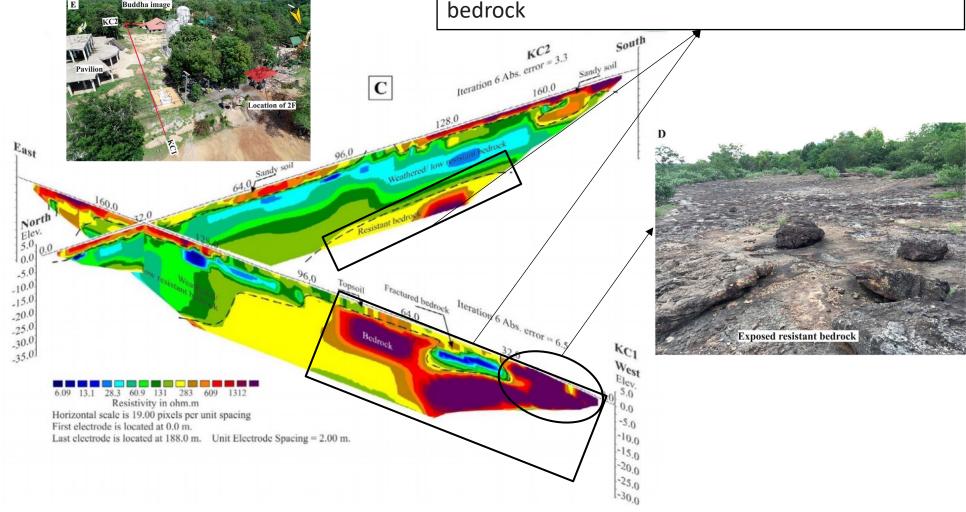
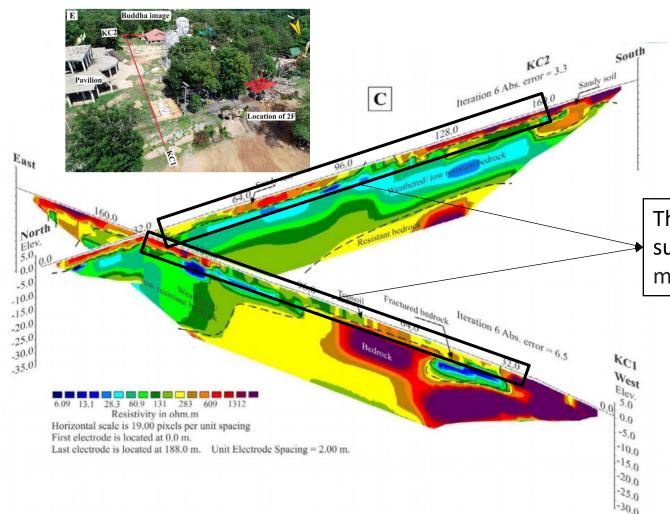
The high Resistivity zone in the near-surface (> 1000 ohm-m) on the depth of 30 m represents resistance bedrock

The low Resistivity zone in the nearsurface (< 5 ohm-m) on the depth of 5-15 m represents a weathered mudstone

- 1. The ERT result from Chaiyaphum Rajabhat University, Subsomboon School, and Kham Hau Chang Temple reveal intact bedrock overlying a relatively weak weathered layer of sandstone-siltstone.
- 2. The depth of bedrock can help determine an appropriate foundation for a given building.
 - Chaiyaphum Rajabhat University= 5-10m
 - Subsomboon School= 0-10m
 - Kham Hau Chang Temple= 10-30 m
