Exploring Failure Evolution of Anti-dip Slate Slope Using Centrifuge Test and Discrete Element Method

Meng-Chia Weng, Chia-Hsun Peng, Wen-Yi Hung, Yu-Jiun Guo
Bulletin of Engineering Geology and the Environment, 83:457 (2024)

Presenter: Wan-Qian Luo

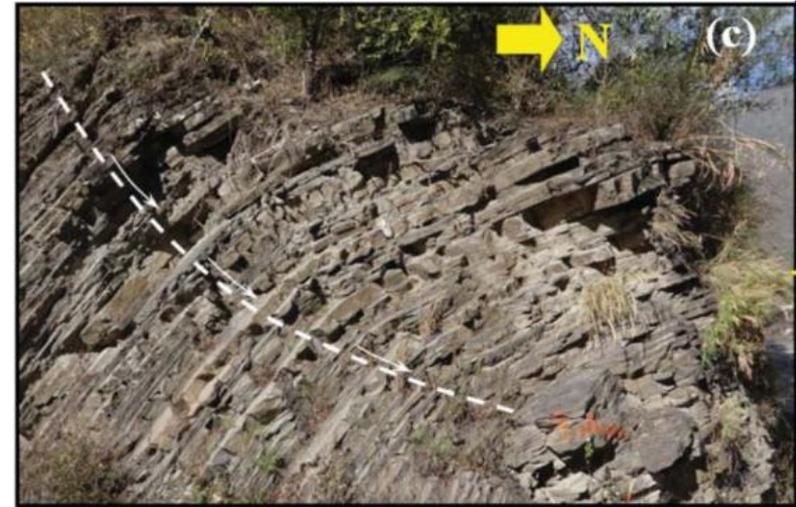
Toppling failure in the right bank of the study area (Lo, 2017)

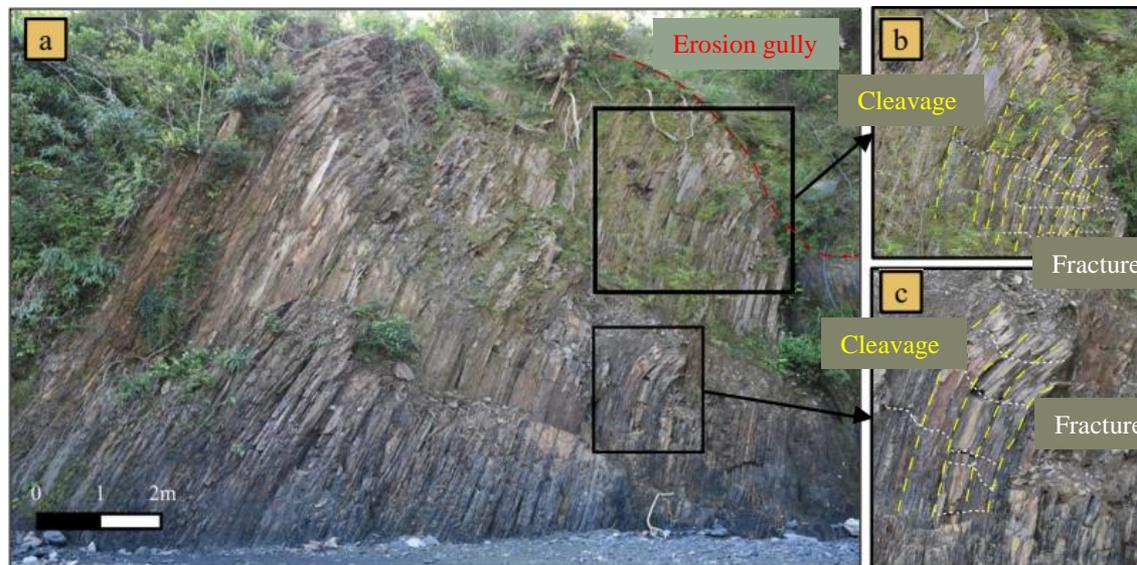
Flexural toppling of anti-dip slate slopes in Ilan, Taiwan (Weng et al., 2024)

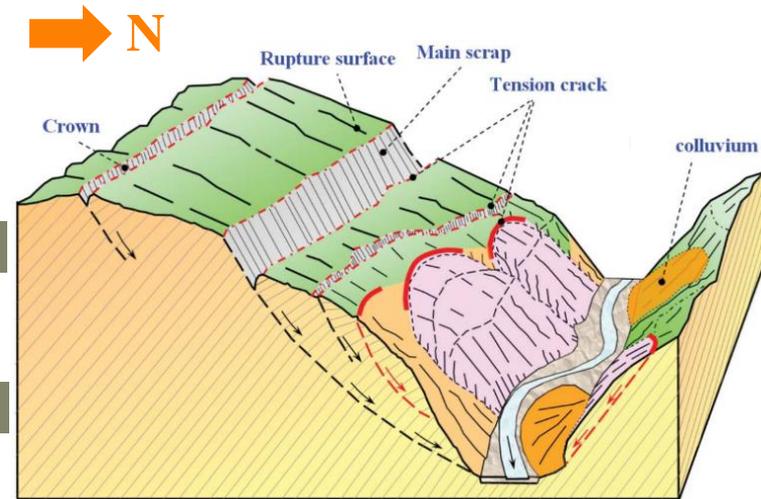
Profile map of the study area (Lo, 2017)

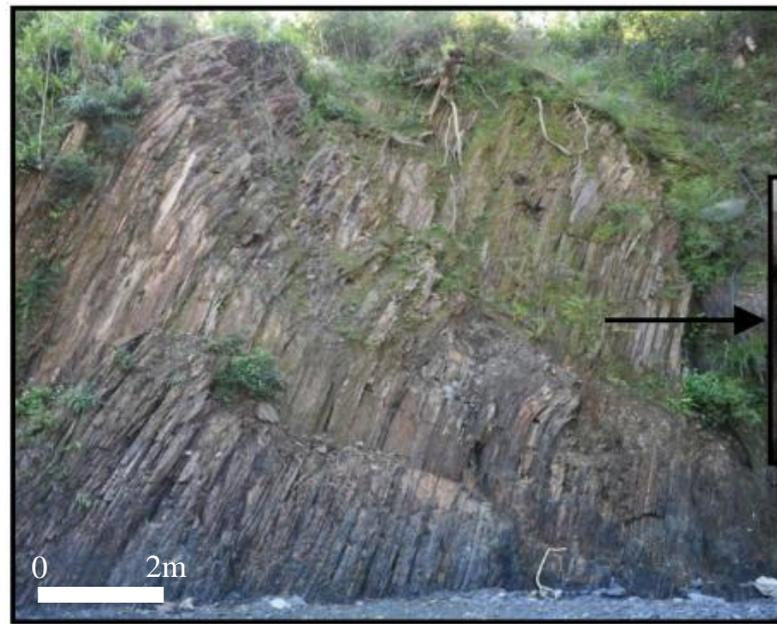
Outcrop of Centrifuge test Sample

Slope high: ~15m

Comprises **slate** and argillite with **mature cleavage**.

Steep angle of the cleavage of 75° opposite to the slope direction.

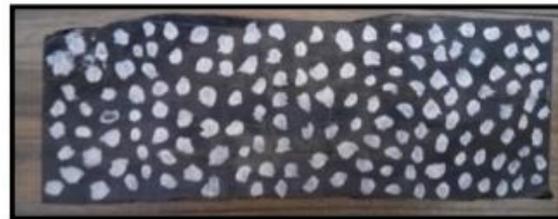
Dot marking on the specimen for PIV analysis

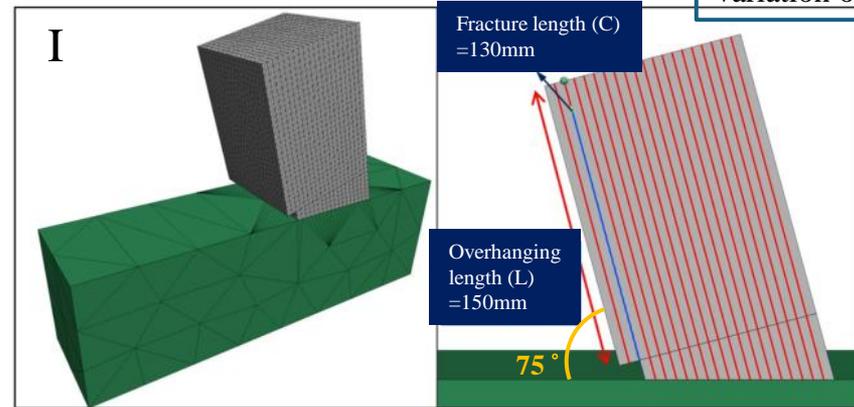
Experimental setup of the centrifuge test

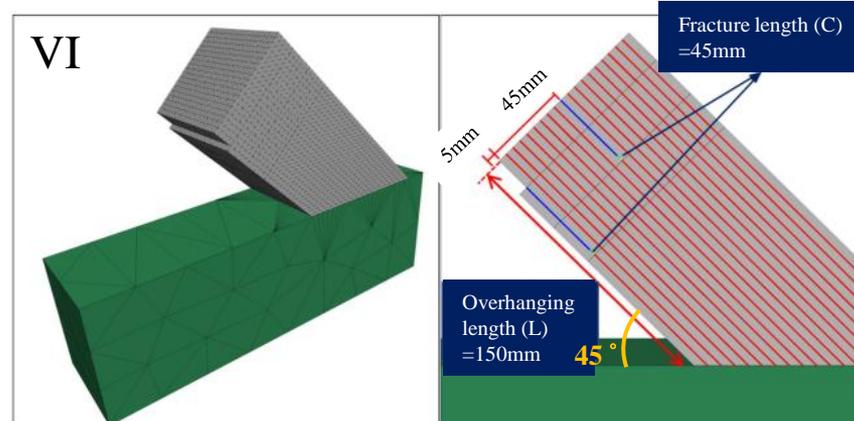
DEM model for Specimen I&VI of centrifuge test

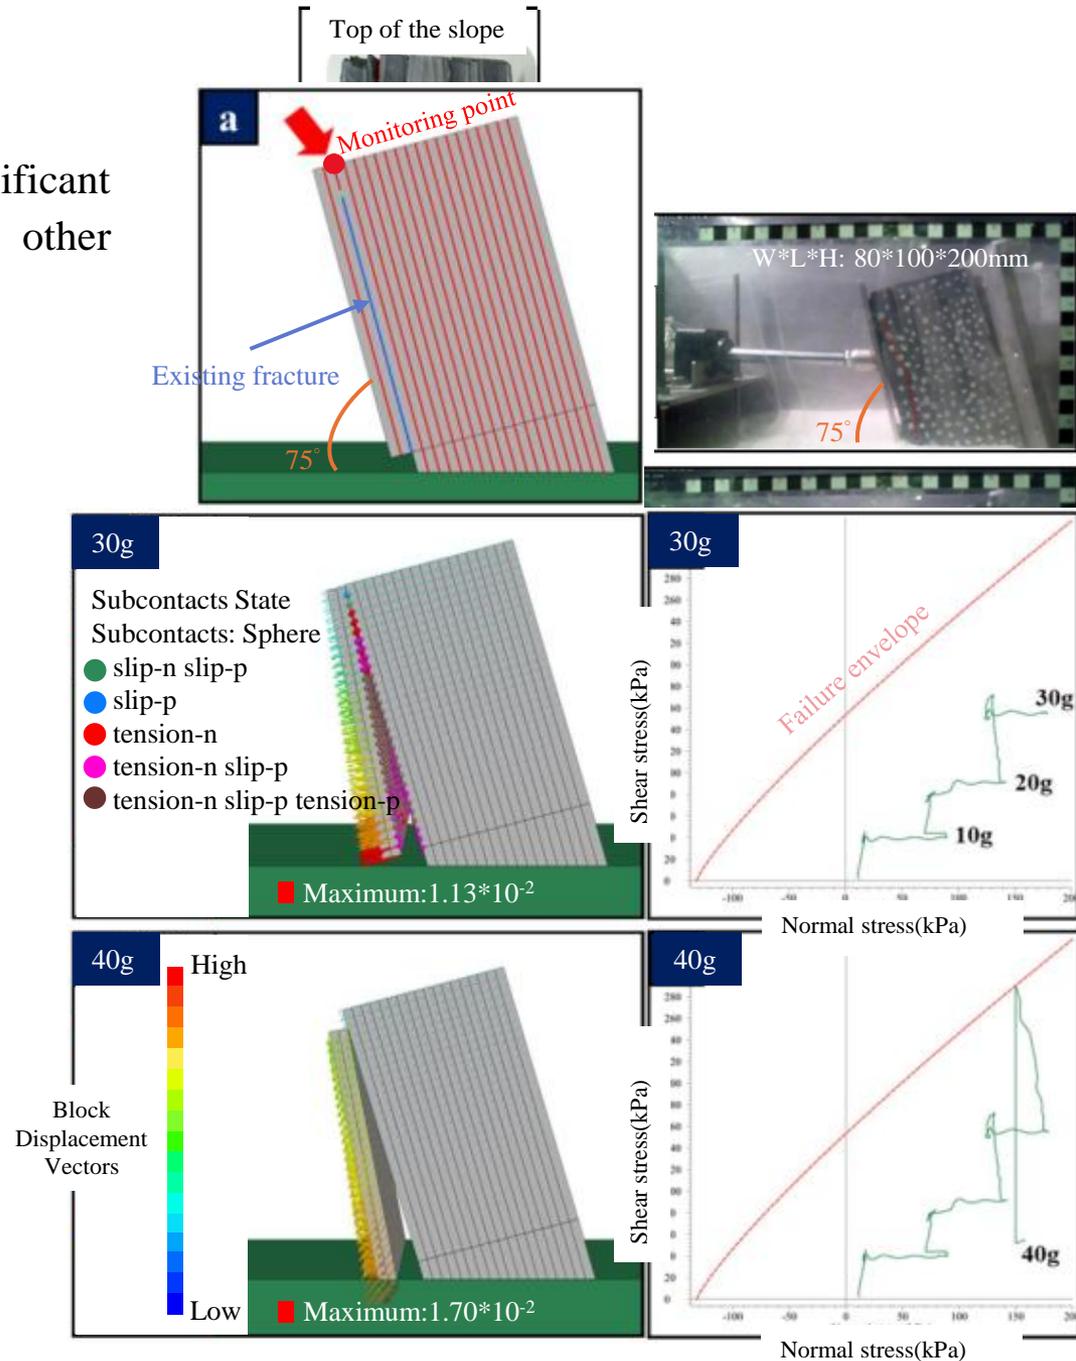
Centrifuge Test: (Sample I)

- A fractures existed at the bottom of slope.
- When gravity =40g, the fracture underwent forward tipping breakage along the slope.

Simulation: (Sample I)

- When gravity =30g, the fracture began to propagate upward.
 - When gravity =40g, the fracture completely penetrated the front layer, forming a free block.
- ✓ The results of the centrifuge tests and DEM simulations are consistent.

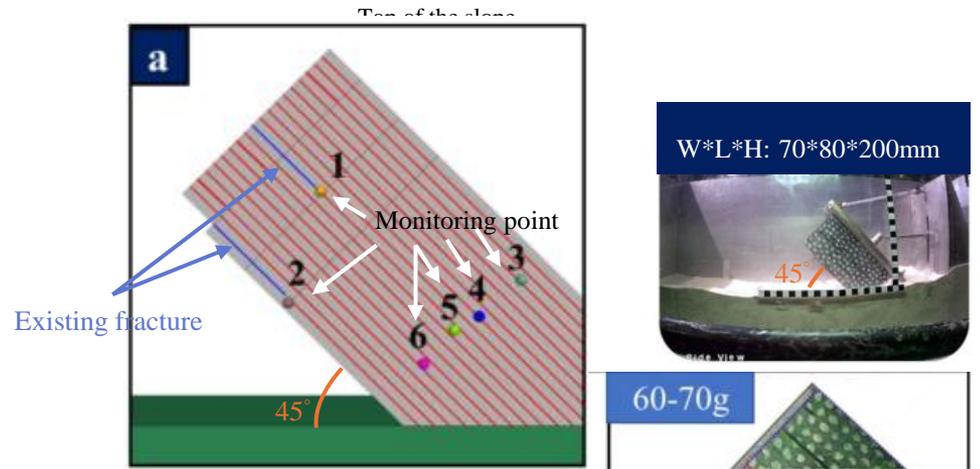
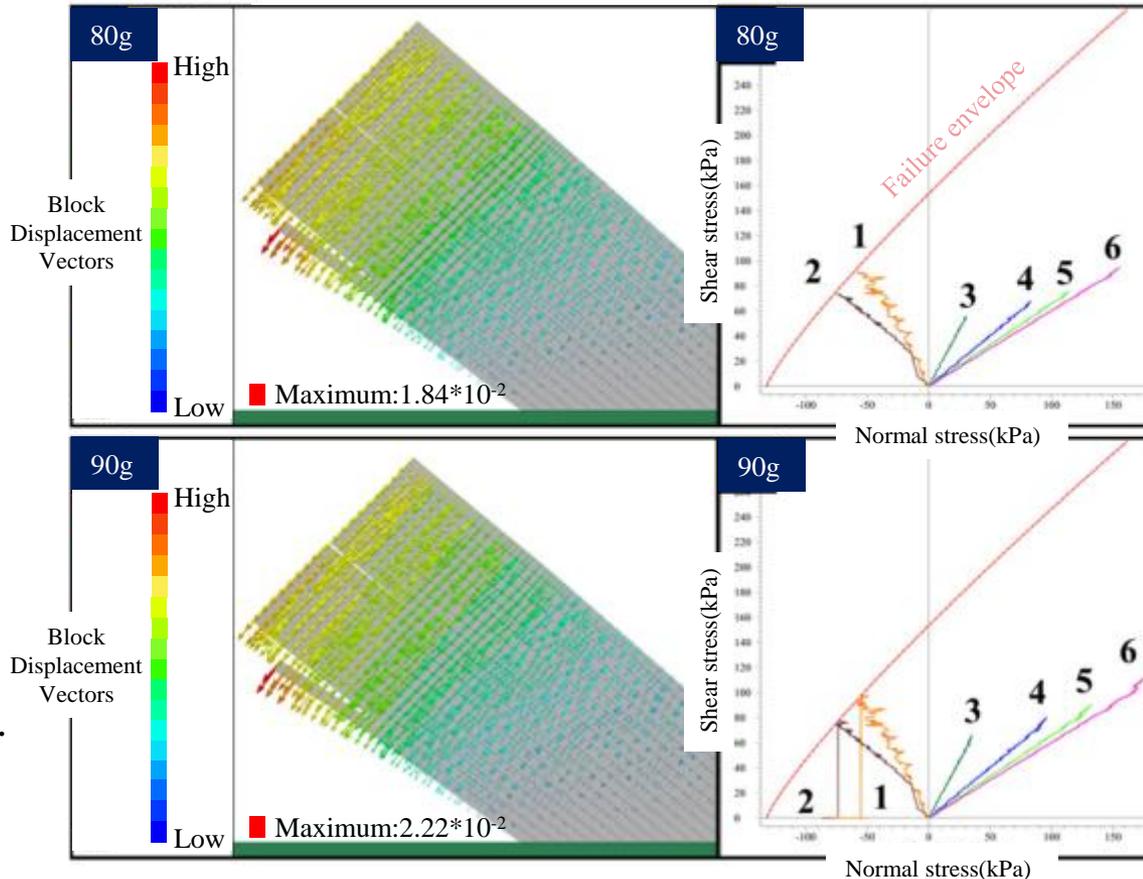
Centrifuge Test: (Sample VI)

- **Two fractures existed at the top of slope.**
- When gravity = **80g**, no failure was observed in the sample.

Simulation: (Sample VI)

- When gravity = **80g**, no failure or fracture propagation was observed.
- When gravity = **90g**, the fractures **began to propagate along the cleavage direction**, leading to toppling failure.

Simulation results of Sample VI

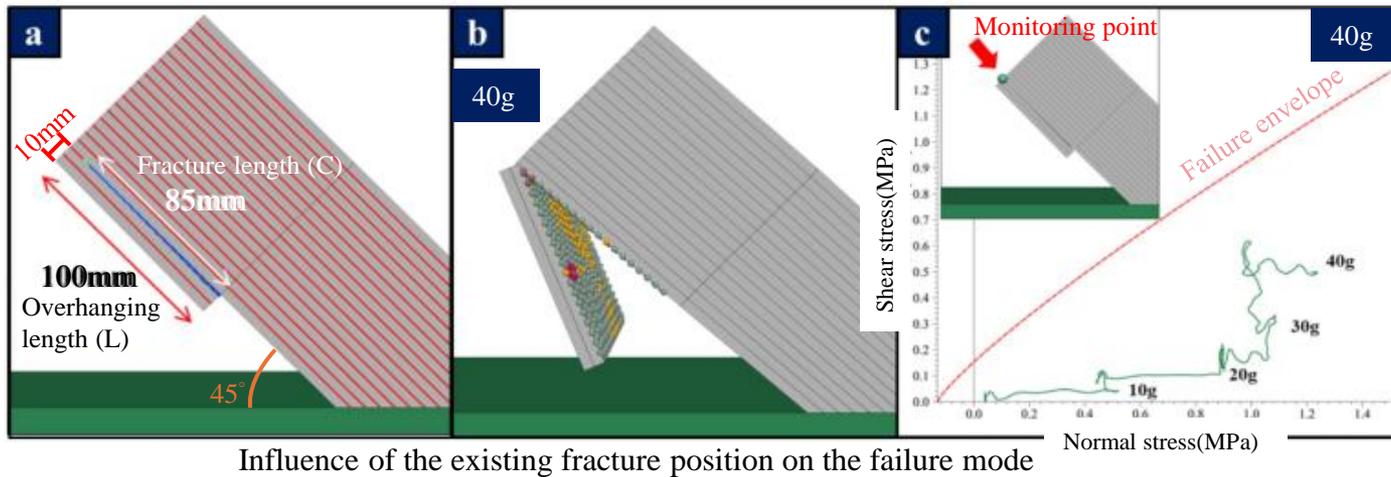
- Lower fractures (a, b, c) → The fractures propagate upward but **do not penetrate** the rock layer.

Influence of the existing fracture position on the failure mode

- The fractures on the upper slope propagate more easily than those on the lower slope due to gravity.

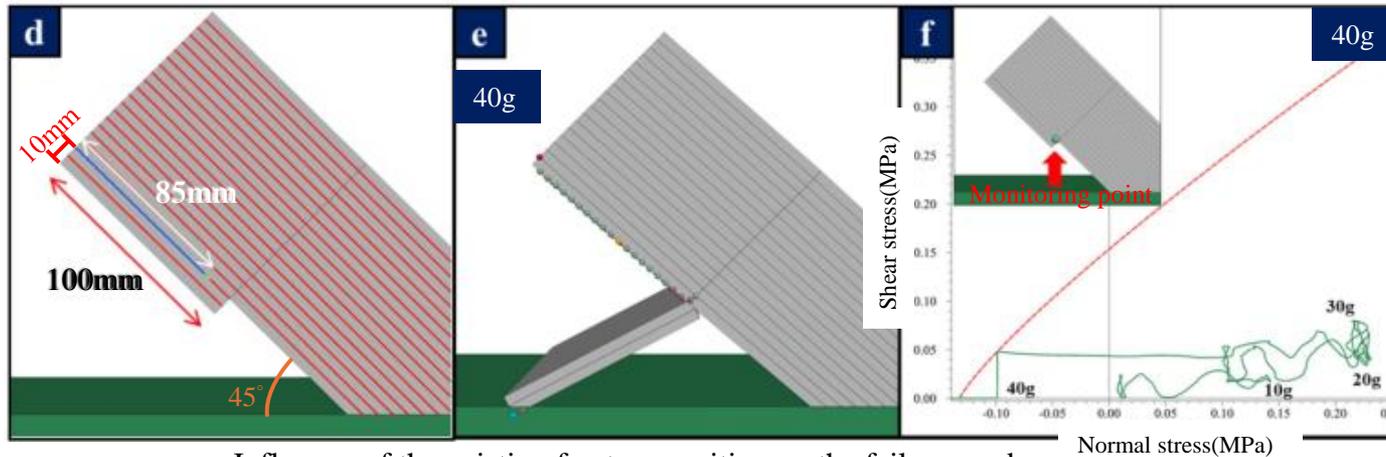
- Upper fractures (d, e, f) → The fractures propagate downward and **penetrate** the rock layer.

Influence of the existing fracture position on the failure mode

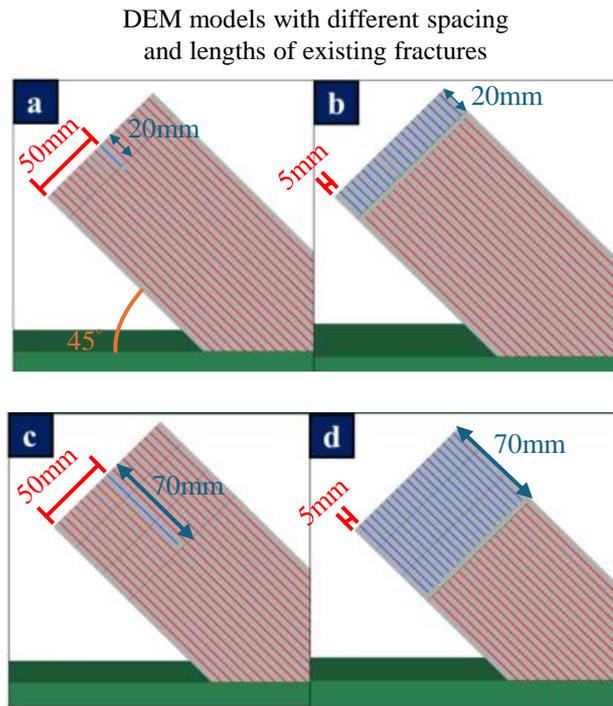
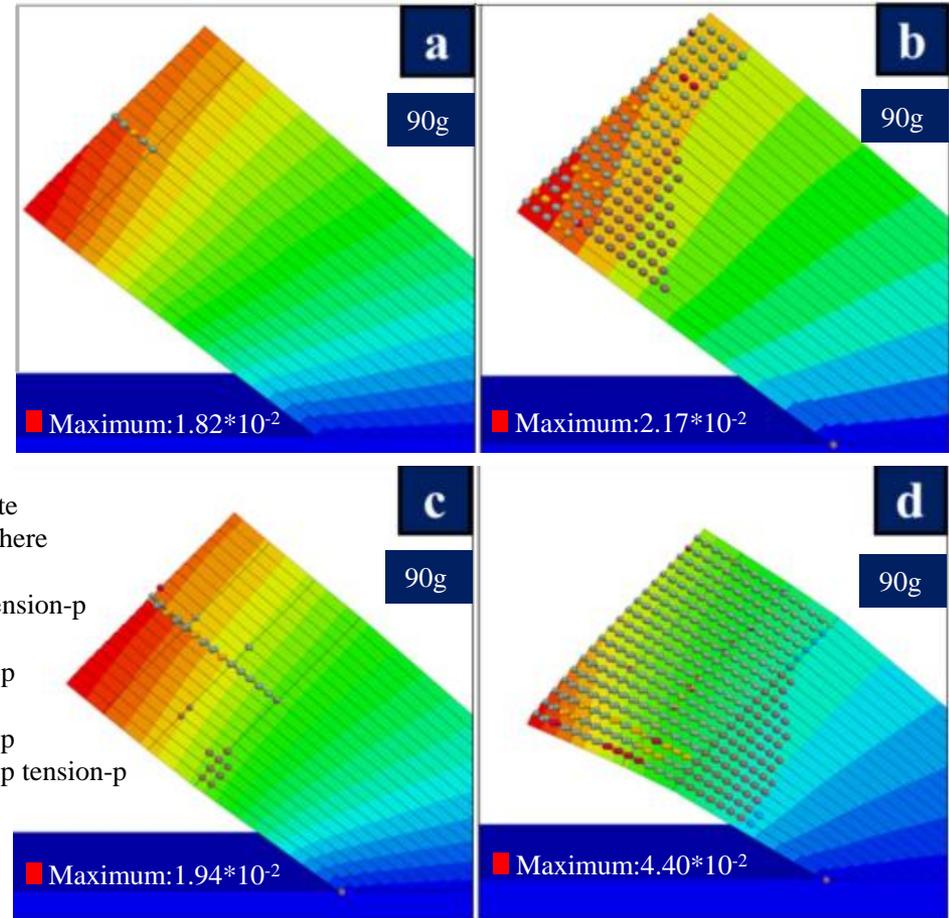
The influence of **fracture spacing and length** on the failure mode

Effect of spacing and length of existing fractures on failure modes

- The **longer the fracture** and the **smaller the spacing**, the greater the degree of failure.
